February 2016

Re: 3M™ Batteries in Use with 3M™ Wireless Communication System C1060 and XT-1 Headsets

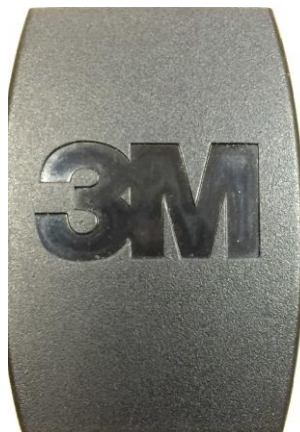
The 3M™ Battery used in the C1060 and XT-1 Headsets (both use the same battery), with the 3M logo engraved on the front of the battery panel. **Note: Batteries which are not marked with the 3M logo are NOT covered by this notification.**

Front of C1060/XT-1 battery with 3M Logo engraved

1. Remove the battery from the headset.
2. Confirm that the battery is a 3M™ Battery by locating the 3M logo engraved on the front battery panel. See front of battery image above.
3. Check the battery for any abnormalities, such as bulging, cracks in the plastic case, and/or deformities in the plastic case.
4. **If the battery looks abnormal in any way, stop using it.**
5. Remove any abnormal battery from use and follow the steps below to either (a) request a free replacement battery or (b) upgrade your system to the 3M™ Drive-Thru Headset System G5.

1. Take a photo of the front and the back of the abnormal battery.
2. Call 3M at 800-453-0775 or send an email to bcسدcomplaints@mmm.com to request a replacement battery.
3. **You will need to send the photo before the battery will be replaced.**
4. 3M will ship you a replacement battery as soon as possible.
5. **By requesting replacement of abnormal batteries, you are committing to stop using all replaced 3M C1060/XT-1 batteries and to take those batteries out of service.**
6. Please properly dispose of the abnormal batteries. Contact Call2Recycle for information about disposal: www.call2recycle.org/locator
